# Manhole Inspection Summary

Manhole # S03EE2006MH

**Location** Address: **6206 BENHURST RD**

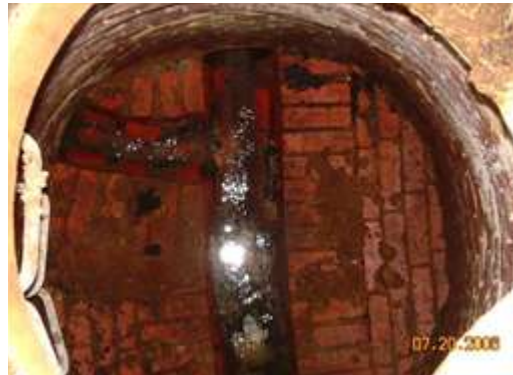
Top View

Frame leaks. Frame offset. Adjustment deterioration and infiltration. Evidence of surcharge - Bench debris. Channel

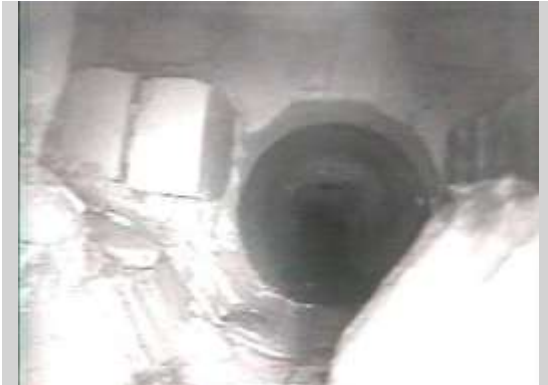
### 8 in. Circular Gravity Sewer Pipe Out @ 12 O'Clock

Infiltration: **Evidence** Pipe Seal Cond: **Unknown**

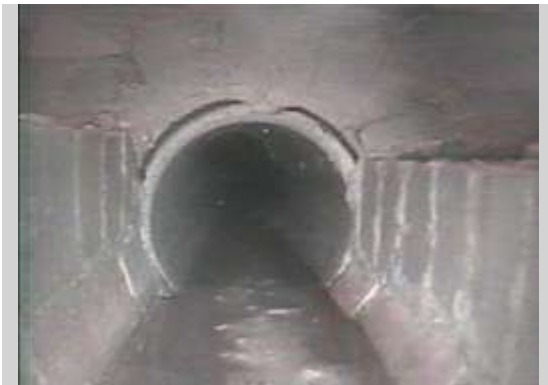
### 8 in. Circular Gravity Sewer Pipe In @ 6 O'Clock

Infiltration: **Evidence** Pipe Seal Cond: **Unknown**

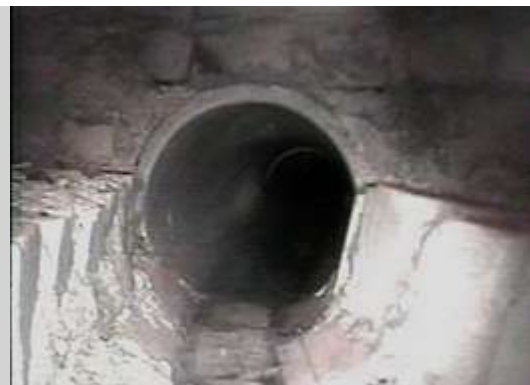
Pipe In @ 9 O'Clock

Barrel deterioration and infiltration.

Infiltration: **Evidence**
